DEPARTMENT OF TRANSPORTATION

Quality Assurance and Source Inspection

Contract #: 04-0120F4Cty: SF/ALA Rte: 80 PM: 13.2/13.9File #: 99.28**WELDING INSPECTION REPORT****Resident Engineer:**Siegenthaler, Peter**Address:** 333 Burma Road**City:** Oakland, CA 94607**Report No:** WIR-019631**Date Inspected:** 24-Jan-2011**Project Name:** SAS Superstructure**OSM Arrival Time:** 700**Prime Contractor:** American Bridge/Fluor Enterprises, a JV**OSM Departure Time:** 1900**Contractor:** Zhenhua Port Machinery Company, Ltd (ZPMC) Chanxing Island**Location:** Shanghai, China**CWI Name:** Mr. LIU HUA JIE**CWI Present:** Yes No**Inspected CWI report:** Yes No N/A**Rod Oven in Use:** Yes No N/A**Electrode to specification:** Yes No N/A**Weld Procedures Followed:** Yes No N/A**Qualified Welders:** Yes No N/A**Verified Joint Fit-up:** Yes No N/A**Approved Drawings:** Yes No N/A**Approved WPS:** Yes No N/A**Delayed / Cancelled:** Yes No N/A**Bridge No:** 34-0006**Component:** OBG Segment**Summary of Items Observed:**

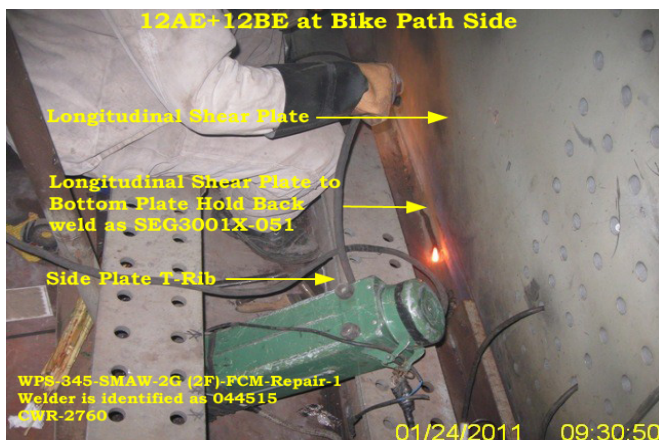
ZPMC welding personnel performing Shielded Metal Arc Welding (SMAW) of Repair weld for the longitudinal shear plate to bottom plate hold back weld joint located on 12AE+12BE at bike path side. The weld is designated as SEG3001X-051. The welder is identified as 044515. ZPMC QC Mr. WANG ZHU was onsite monitoring the welding variables. The inprocess SMAW appears to be progressing in compliance with WPS-345-SMAW-2G (2F)-FCM-Repair-1. The weld repair report number is named as CWR-2760. Further weld detail mention in

attached picture.

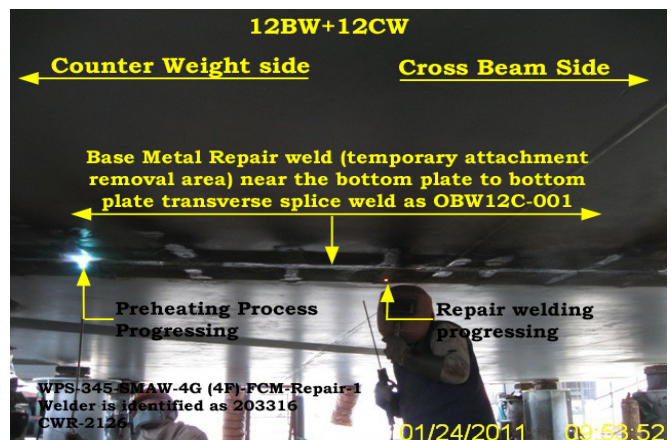
ZPMC welding personnel performing Shielded Metal Arc Welding (SMAW) of Base Metal Repair weld (temporary attachment removal area) near the bottom plate to bottom plate transverse splice weld joint located on 12BW+12CW at counter weight side. The location near the weld is designated as OBW12C-001. The welder is identified as 203316. ZPMC QC Mr. ZHOU PENG was onsite monitoring the welding variables. The inprocess SMAW appears to be progressing in compliance with WPS-345-SMAW-4G (4F)-FCM-Repair-1. The weld repair report number is named as CWR-2126. Further weld detail mention in attached picture.
